Structural Assessment Report

Shelly Hebert –Shea Memorial Arena 400 Ferguson Avenue, Temiskaming Shores

Our Project Number:
STS 2024-0142

August 2024

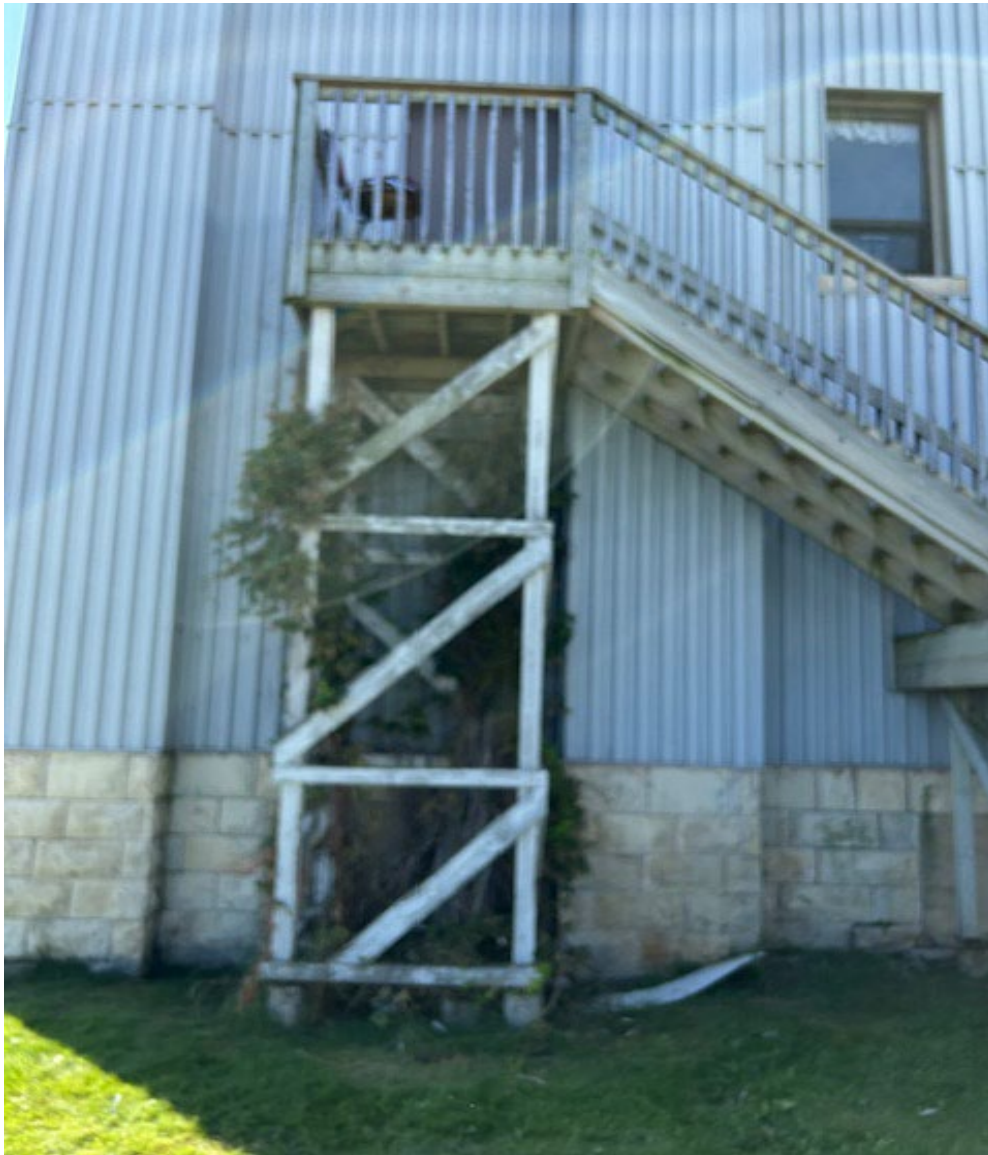
The stairs

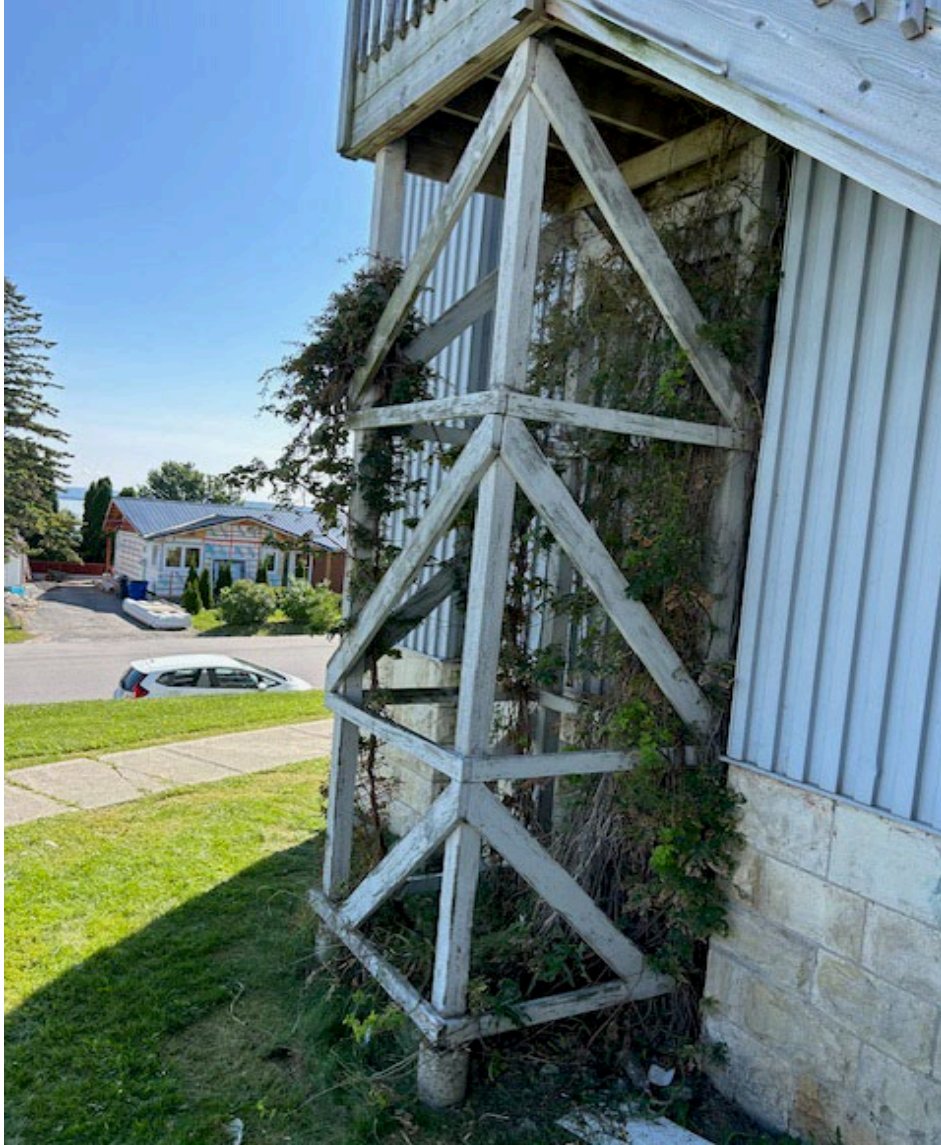
The foundation supports for the posts are of structural concerns. Rust has penetrated the saddle and an imminent failure may happen from the foundation level.

Pier supports – they are lifting

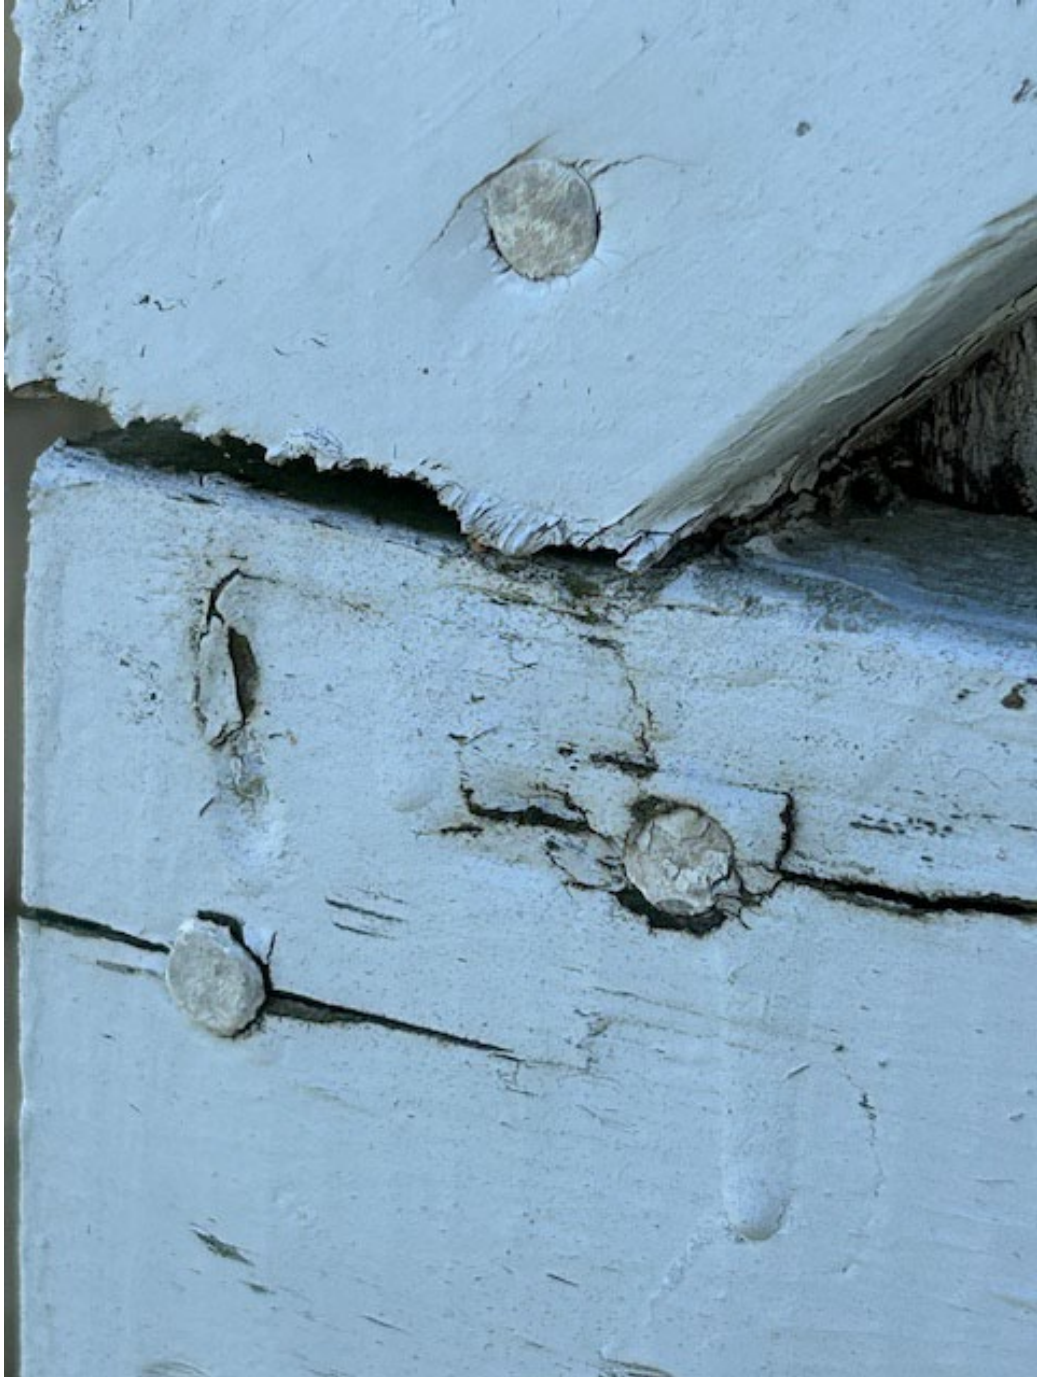
Rut 2x 6 -pop out nails

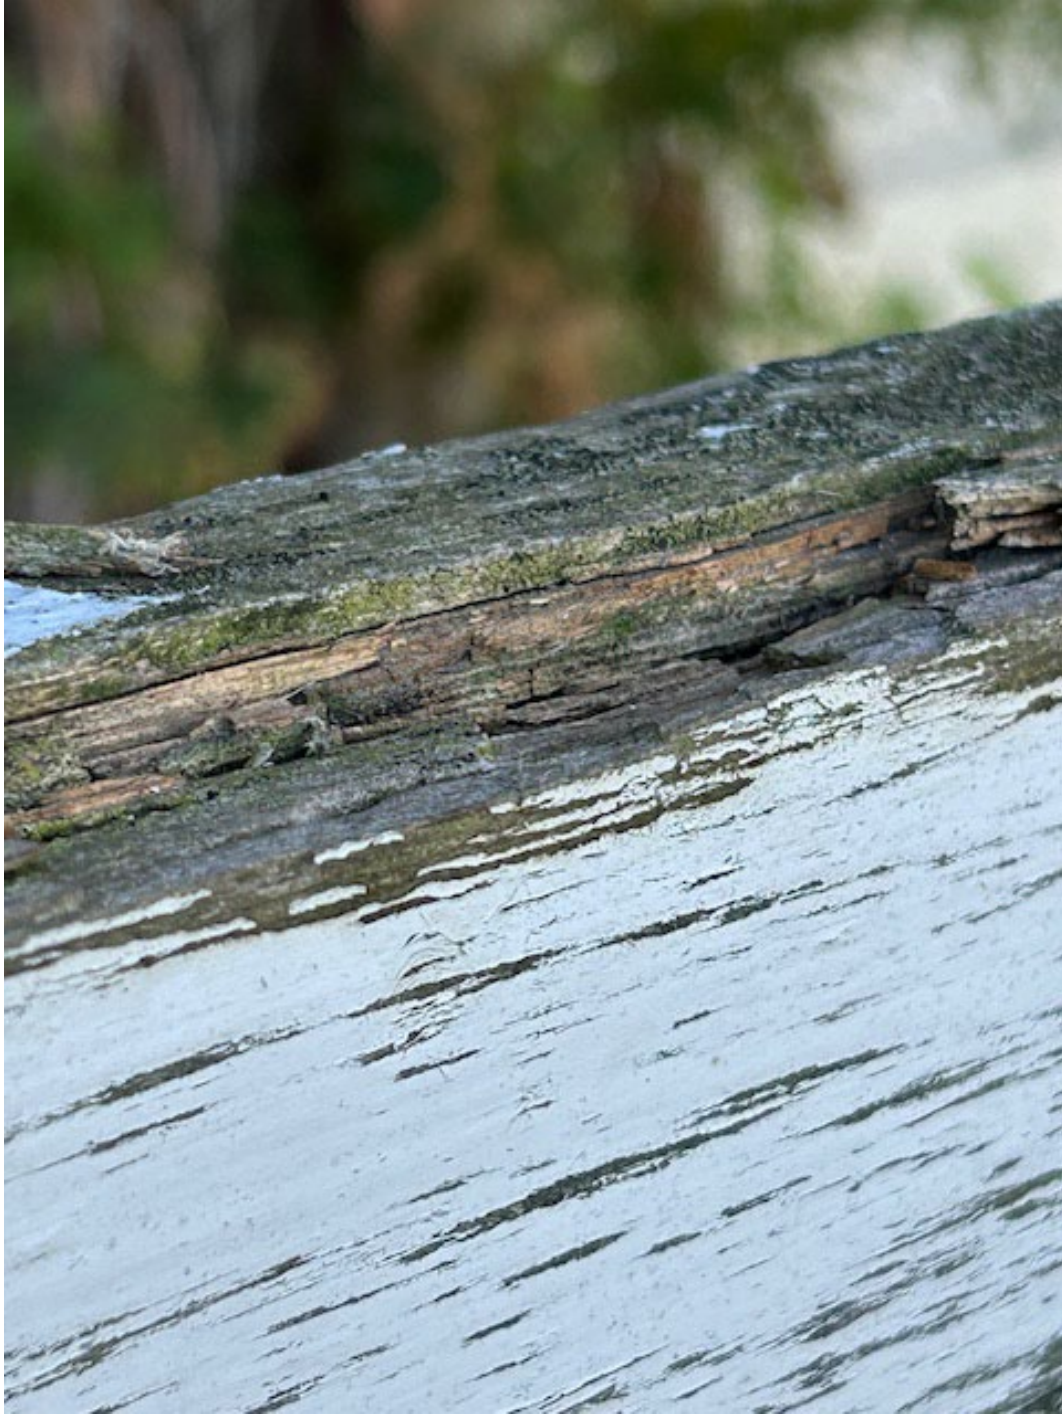
The exit stair is constructed of wood; it is apparent that the support for the upper platform is the oldest part of the structure and is in the poorest condition. There is considerable evidence of rot where one piece of wood overlaps trapping moisture.

Rotten wood

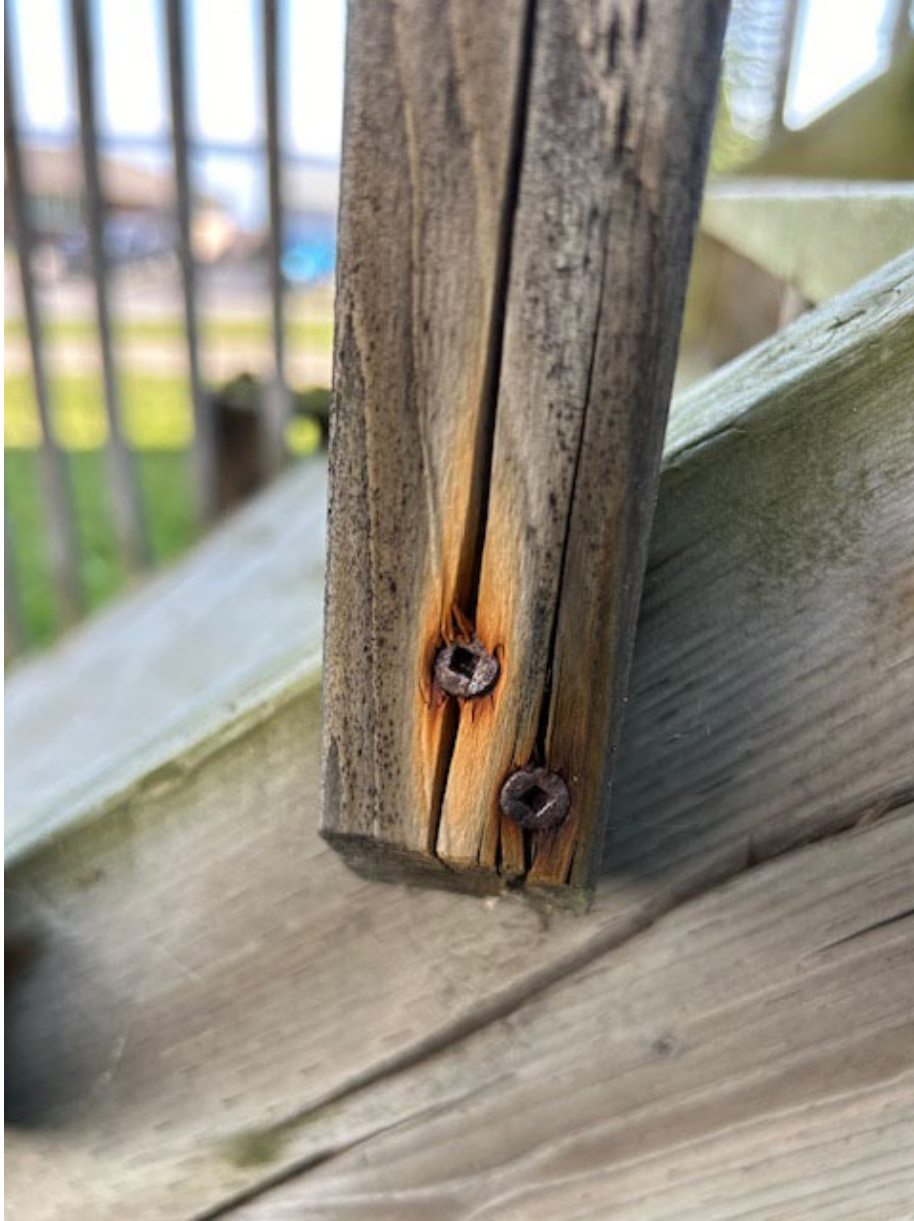
Split picket

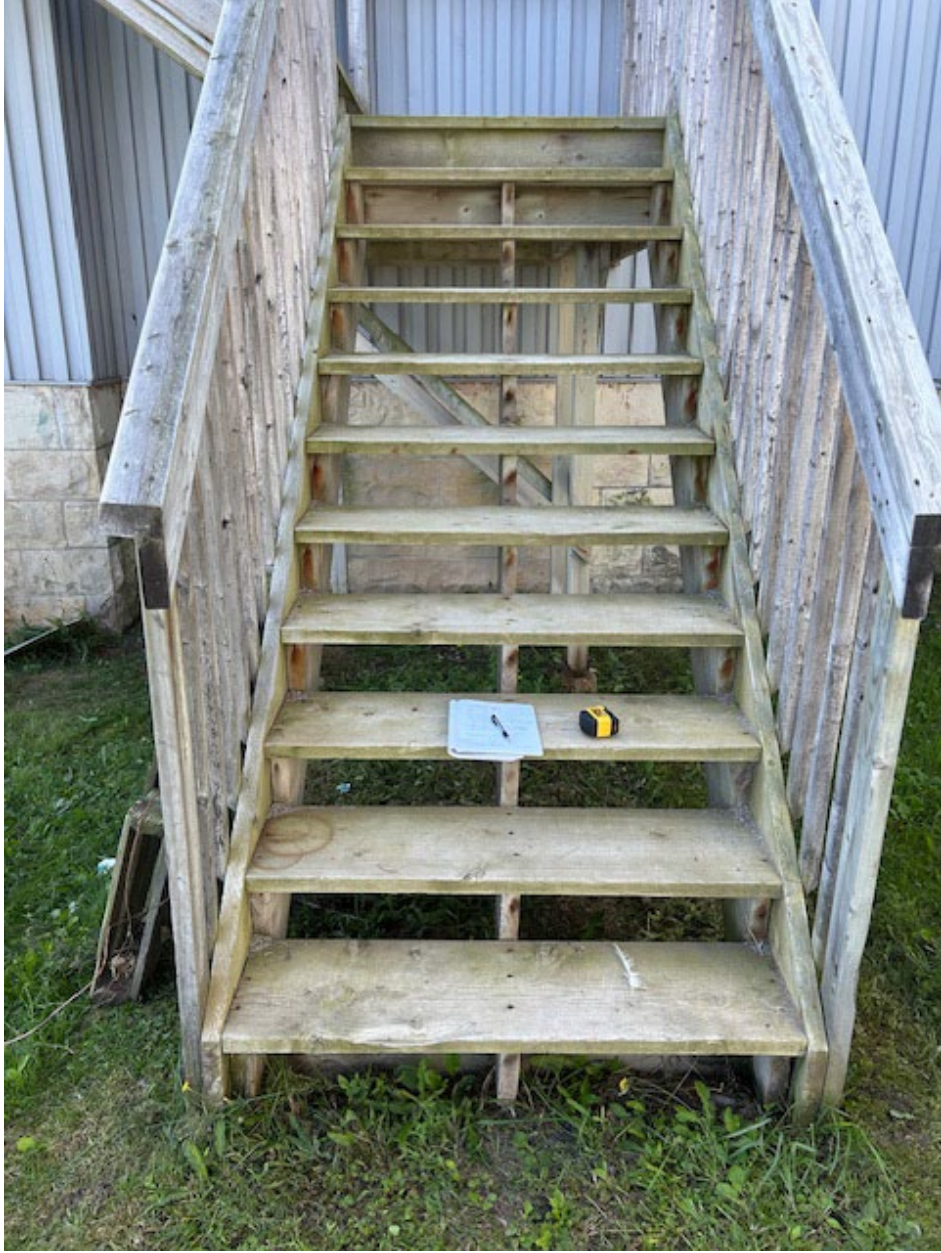
The handrail and method of fastening on the stairs is not per the Ontario Building code.

The railings are wobbling

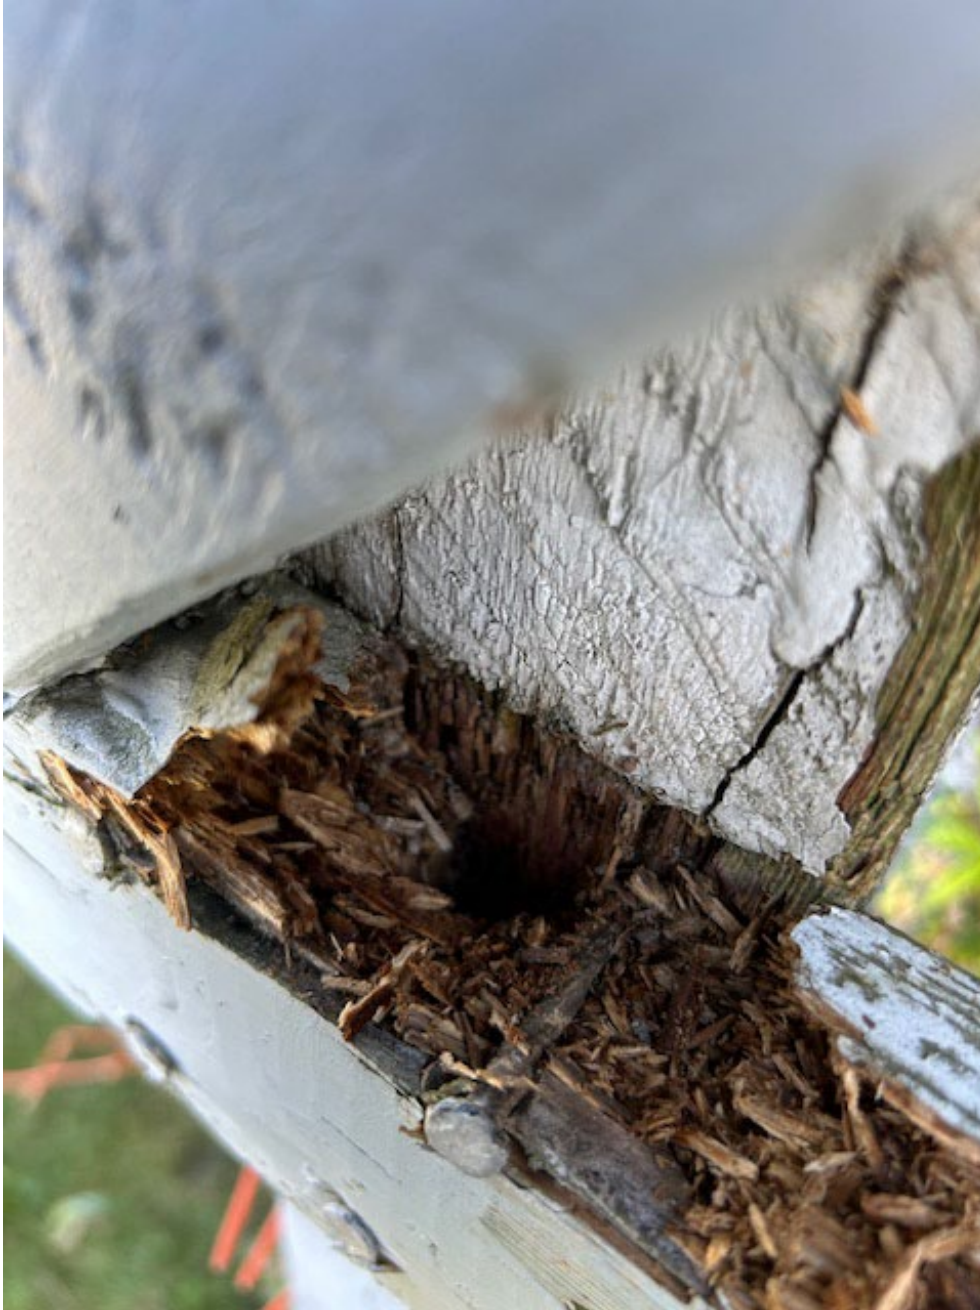
More rot
